AIA Document G704™ - 2000**Certificate of Substantial Completion****PROJECT:**

(Name and address)
Oak Creek Village Apartments
2324 Wilson Street
Austin, Texas 78704

CONTRACT FOR: General Construction
CONTRACT DATE: May 21st, 2014

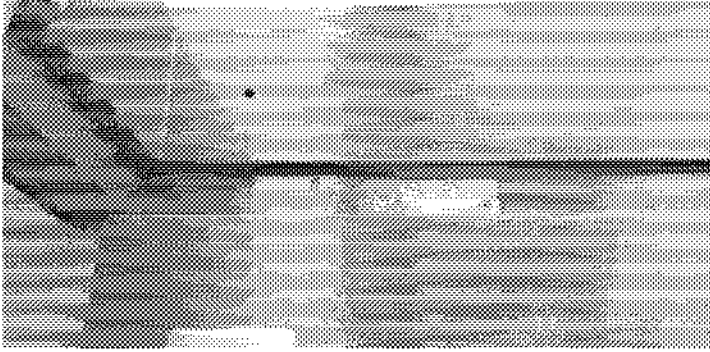
Location	Item	Description	Photo
Fire Doors, Phase 1A South	#17	UL label painted over - unable to confirm fire rating. No seals installed.

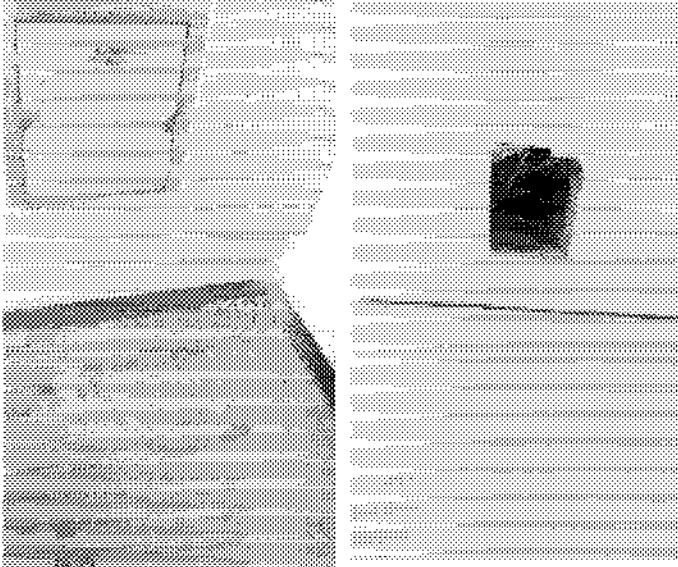
Trash Vestibule, Bldg 4	#18	Large concrete drop on floor. Hole in ceiling. Plastic sheeting still on trash chute door.

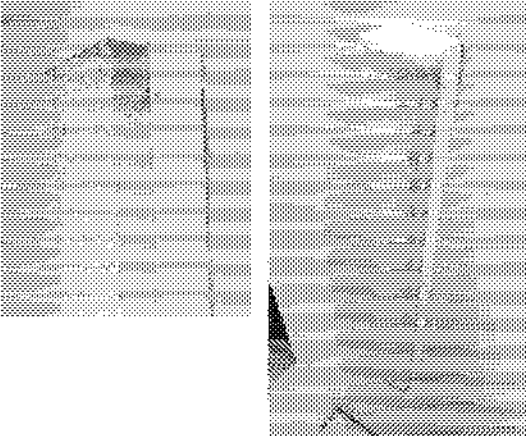
Corridors, Lighting	#19	Soffit above light fixtures is unpainted. Surprisingly large amounts of dead bugs were observed in the lenses of many lights - recommend checking that wiring knock-outs are sealed around cabling, and lenses are properly secured.

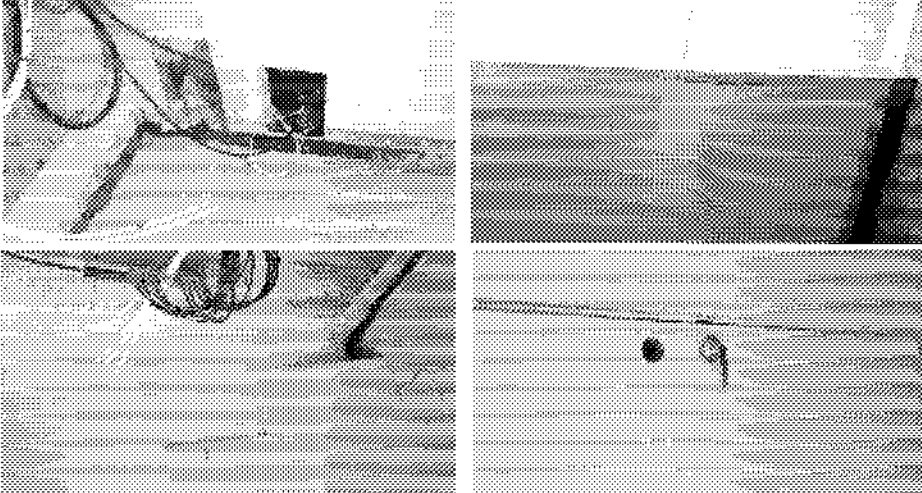
Location	Item	Description	Photo
BCR/IDF, Building 4	#20	BCR/IDF room interior unfinished.

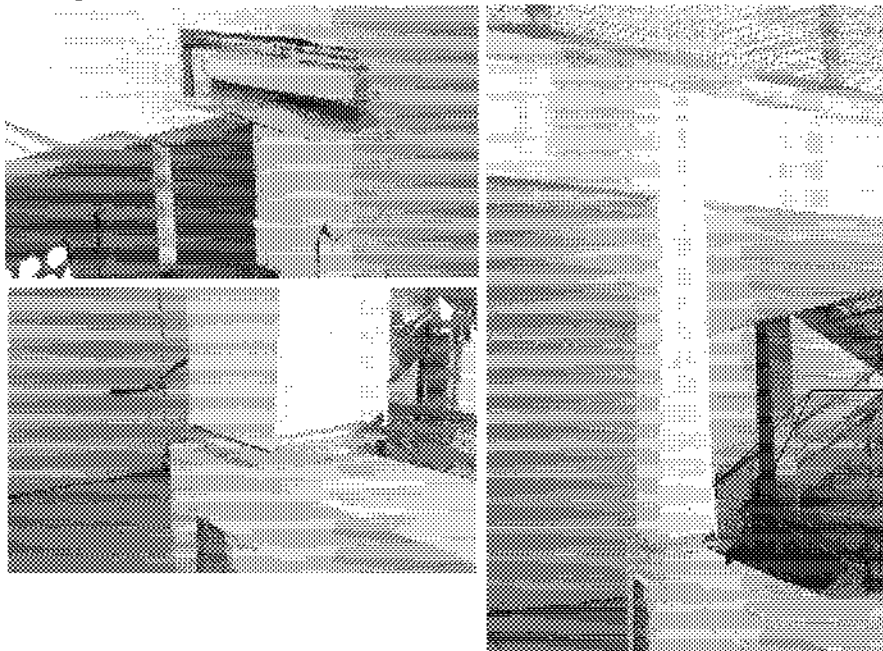
Stucco flashing	#21	Base-of-stucco wall flashing was reviewed at an earlier date at the north wall of the parking garage, and similar flashing mistakes are repeated throughout the project. Issues include large, superfluous profiles needlessly installed above adjoining elements (other walls, flashing). The column depicted below should have it's stucco tied in with the parapet wall below, not interrupted by base & parapet cap flashing.
-----------------	-----	---

Stucco flares out near base, not plumb; stucco should have tied in with parapet below; stop parapet cap flashing at column face

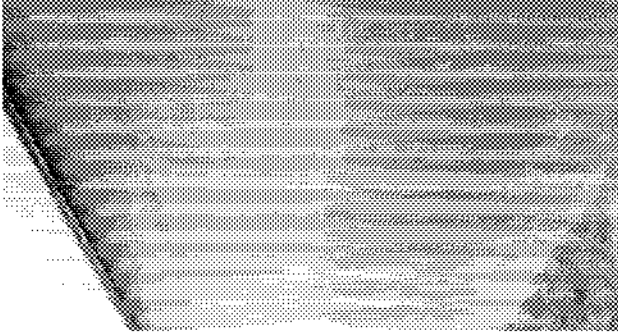
Location	ID	Report Notes	Photos
Garage, north wall	#1	Staining observed below a visible pipe penetration at stucco/concrete transition line.

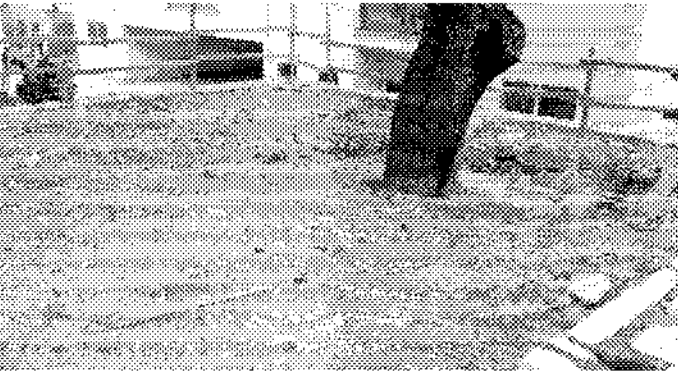
Grading, Pavilion Area	#2	Original survey indicates base elevation of tree 306 to be 570.88', and proposed final grade surrounding this tree to be 569'. Rough grade appears to be installed at least 12" higher than tree base, with topsoil not yet installed.

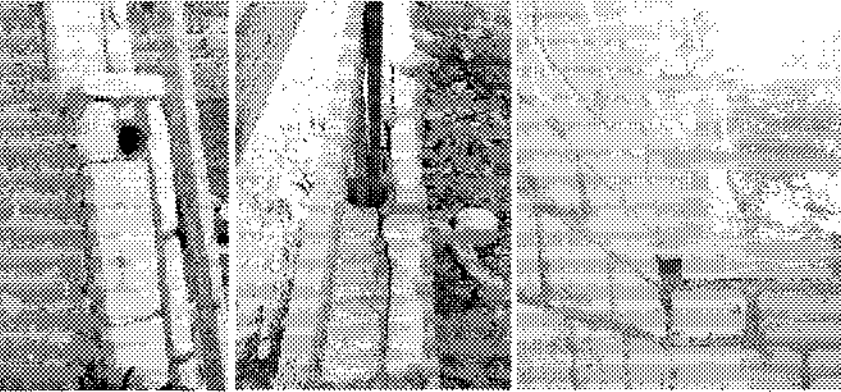
Retaining walls, Pavilion area	#3	Retaining wall mortar is failing & cracking apart in many locations. Cap stones are loose and in danger of falling out.

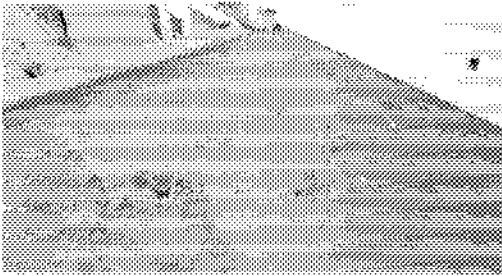
Location	ID	Issues	Notes
6th Floor Roof Deck	#4	Ponding observed at low-slope roof @ South Roof Deck - up to 1" standing water near outlet points.

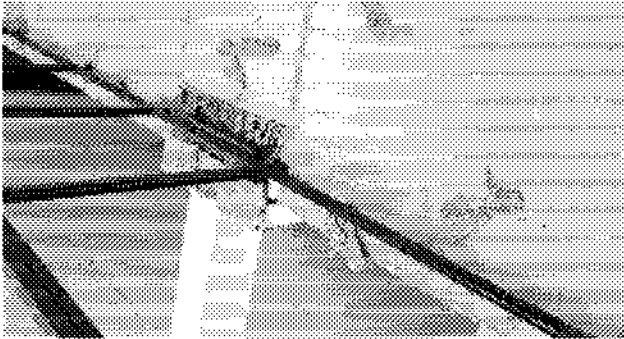
6th Floor, Building A	#5	Exposed plywood & structural framing visible at tops of several corridor pilasters.

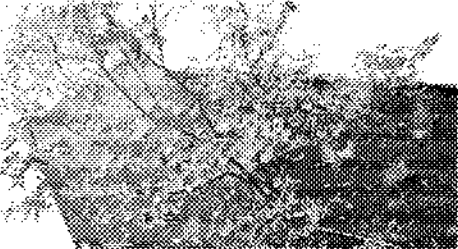
Phase 1A Landscaping	#7	All Japanese Maple trees exhibit signs of stress - singed leaves.

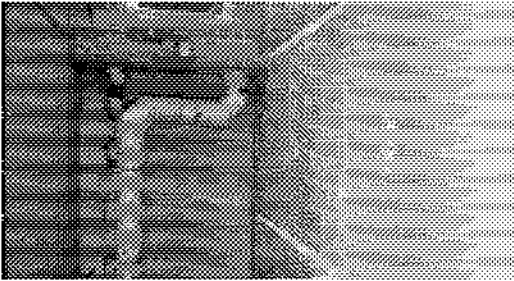
Location	Item	Description	Photo
Garage	#8	Parking spaces 162 (G1) and 72 (G2) require wheel stops to protect drain pipes that were routed close to the ground.

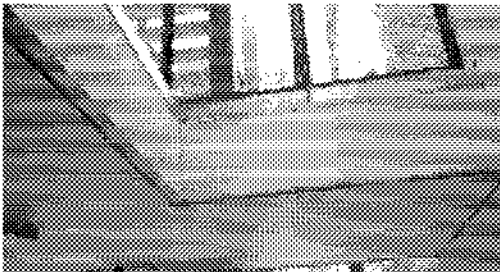
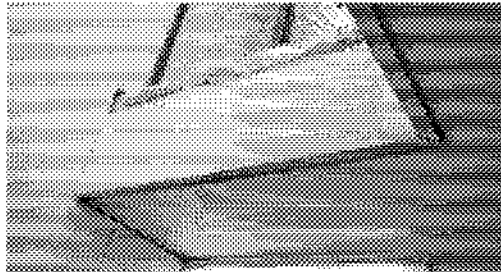
Stair 1 North	#9	<ul style="list-style-type: none"> - Handprint & writing in the concrete of 2 stair landings. - Egress gate at level 3 is to be equipped with spring hinges for automatic closing, per A8.08 detail. Currently installed standard, non-closing hinges. 	
Building A Corridors	#10	Concrete & waterproofing staining observed on aluminum edging in multiple locations.

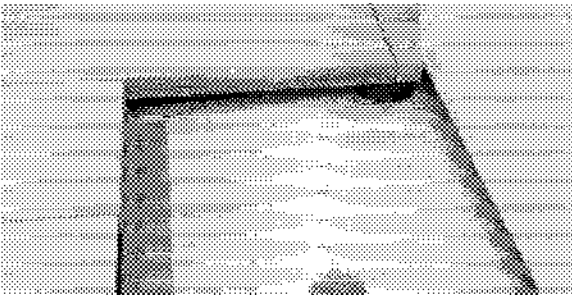
Building A Corridors	#11	Cardboard and masonry debris observed underneath paver system - remove all trash & possible drainage obstructions.

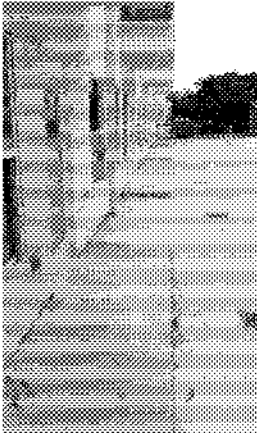
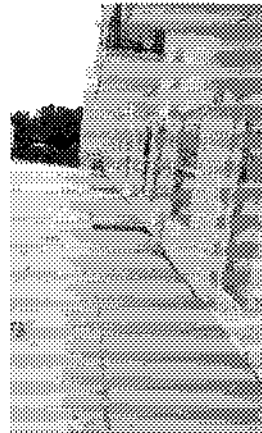
Upper Courtyard facing units, level 3	#12	Balconies @ level 3 should provide 5'-0" minimum clear width (face of wall or wall-mounted object to inside face of railing), per CDs, for 'BF' unit accessibility.

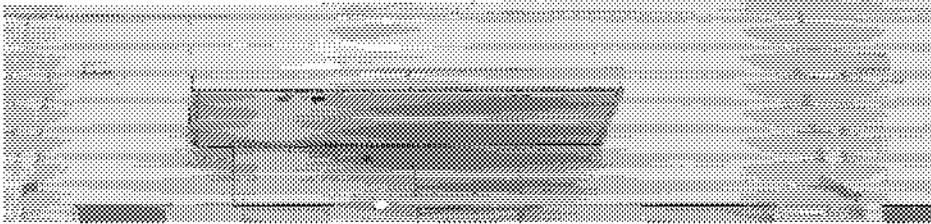
Location	Item	Description	Photo
Roof Overflows	#13	Sheet metal edges & seaming at roof overflow openings is substandard quality, generally. Gaps and imperfections are visible from ground level, 40' away.

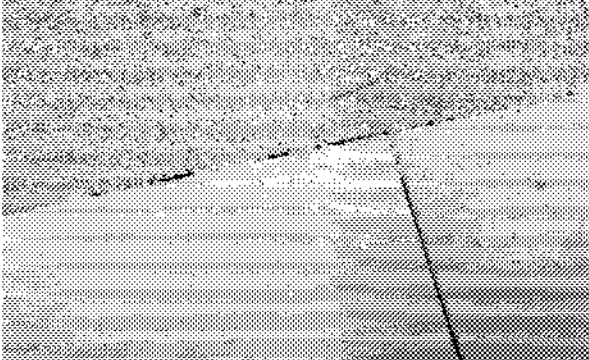
Corridor gravel beds	#14	Position perf steel edging to eliminate gap at paver edge.

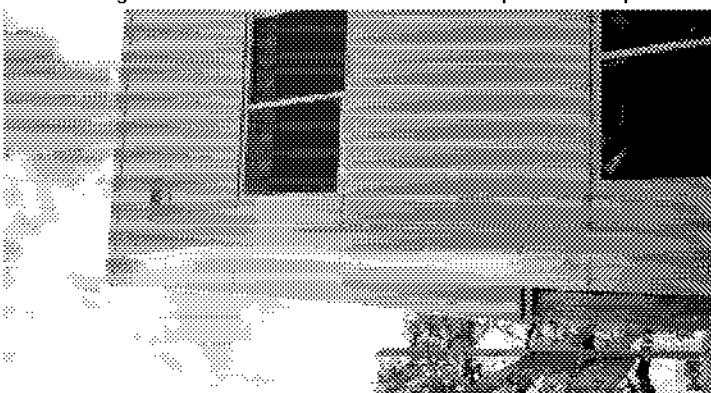
Building 3, SE corner	#15	Wall staining from overflow outlet - check roof slope & downspout.

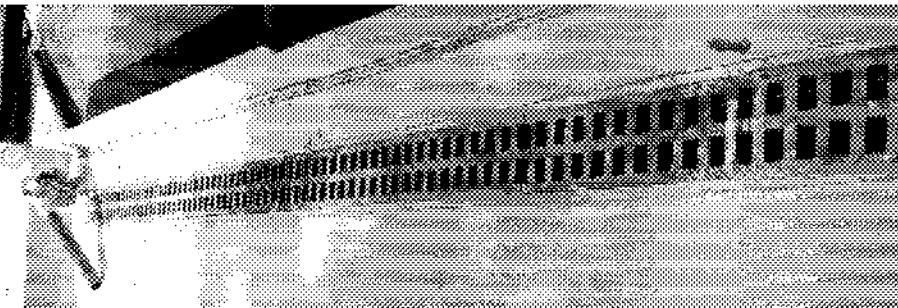
Sidewalk connection to podium	#16	Drain grates in pedestrian walkways must meet ADA/TAS requirements for accessibility. Currently installed trench drain cover has openings that are too large. (TAS 302.3)

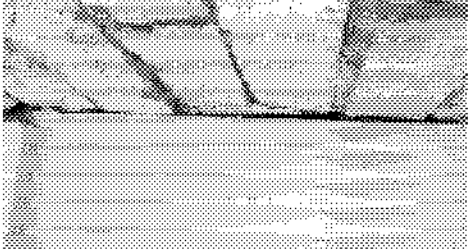
Location	Item	Observation	Photo
Building 3, #17 SW corner		Tyvek visible at meeting of retaining wall & building corner

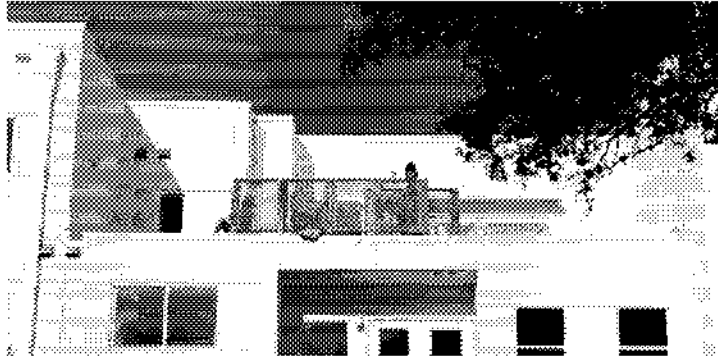
Building #18
3, South
Roof
Deck

Roof deck railing vertical post spacing is not per design. PC0-044 shows 5' to 6' spacing. Please explain reasoning behind this change.

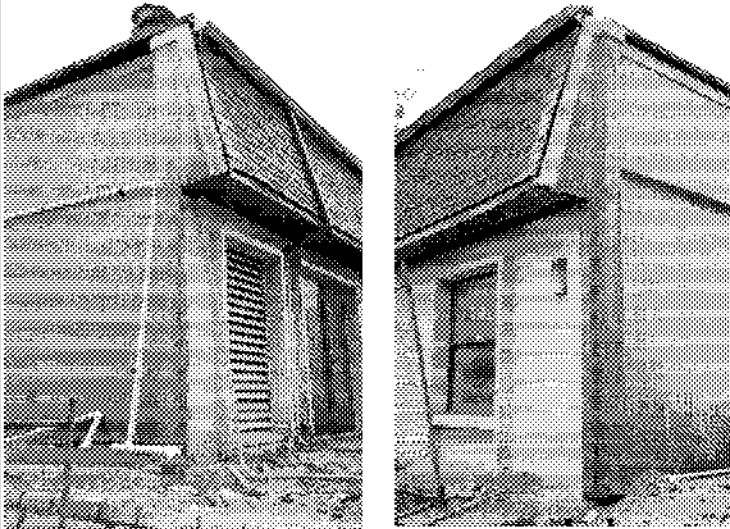
Location	Photo	Observation	Notes
Chiller Building	#1	<p>New east exterior wall of chiller building appears to be incomplete, and vulnerable to water intrusion/damage. Tyvek visible at roof shingle edge. Gutter cut off at roof edge, empties onto new wood trim @ edge of cut roof. Exterior wood wall panels appear to be absorbing water.</p>

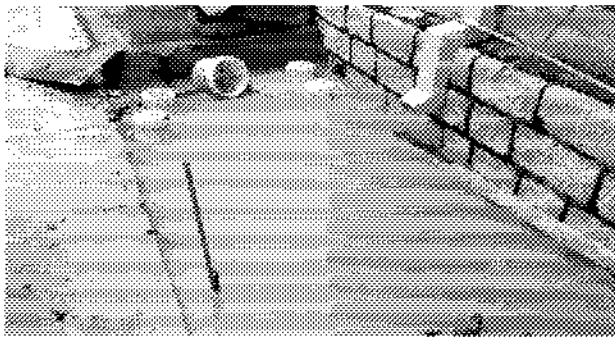
South End, Building 1	#2	<p>Small landscaping pocket bounded by sidewalks takes on water faster than it can be absorbed.</p>

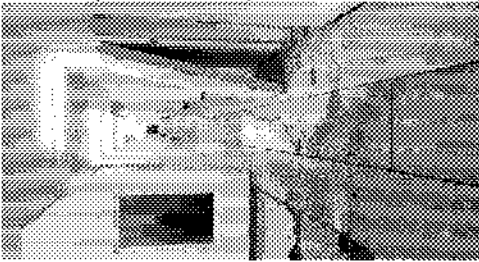
Corridors	#3	<p>Concrete pavers are not protected, accumulating construction debris</p>

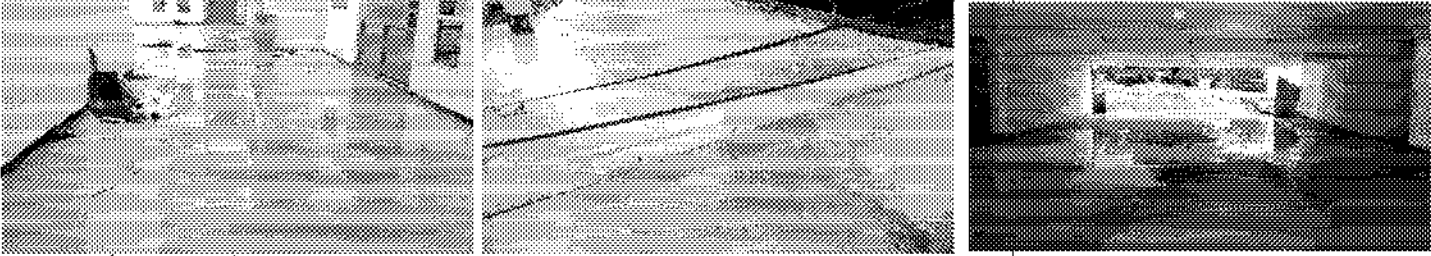
Podium Deck	#4	Ponding observed at podium deck - drains appear to have protective coverings. Confirm drains are clear of debris (including concrete) and functioning correctly.

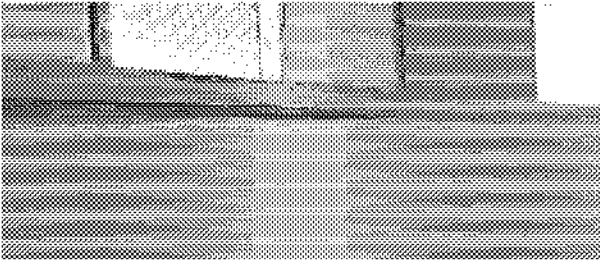
3rd Floor, Building 3, Breezeway entry	#5	Ceiling edge transitions are very rough - not floated well, with joint compound in the aluminum trim. Most lights are not yet installed.

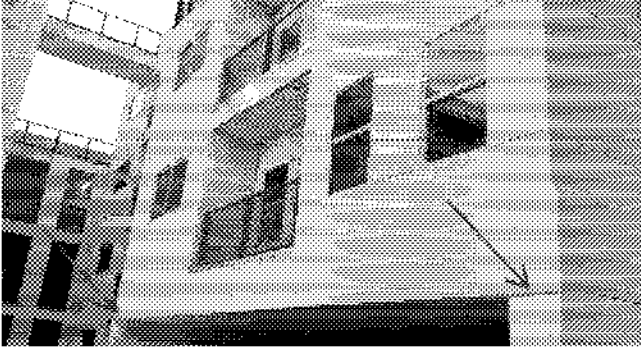
Building 3, Level 3	#6	Stucco control joints missing.

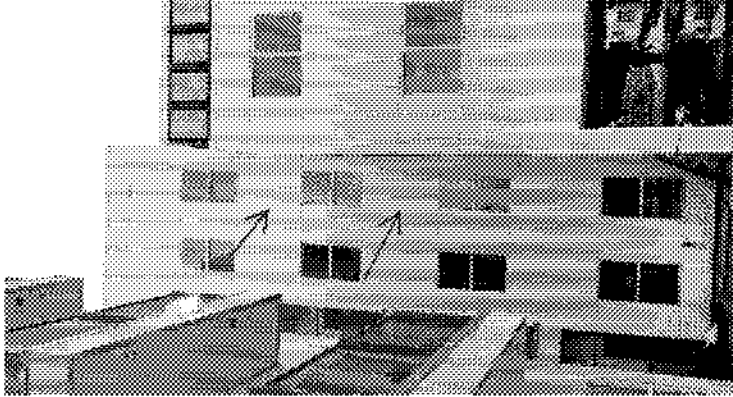
Building 3	#7	Staining observed below window corners. Confirm the cause of this staining and repair. Check seals around windows for water/air tightness.

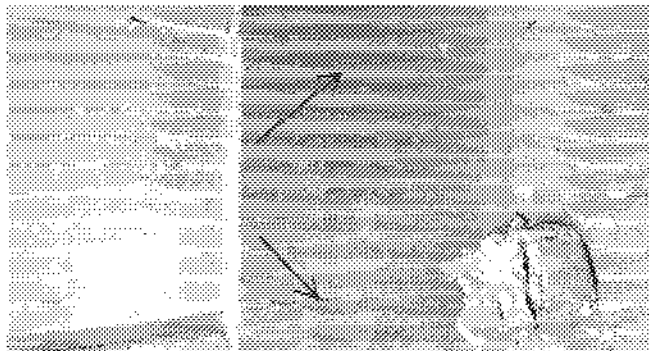
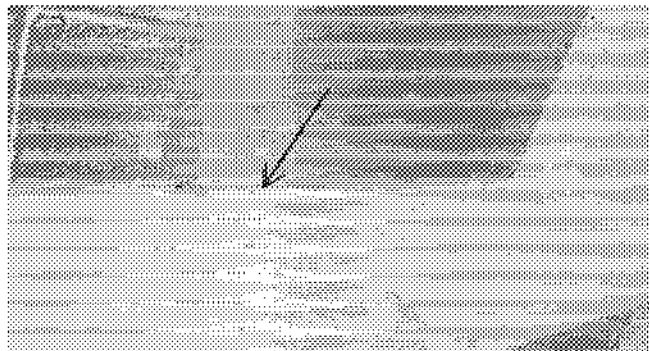
Location	Item	Observation	Photo
Stair A North, Level 2	#8	Cracking observed at concrete beam & concrete column intersection. Confirm whether or not this is only superficial, or extends through to the structural concrete.

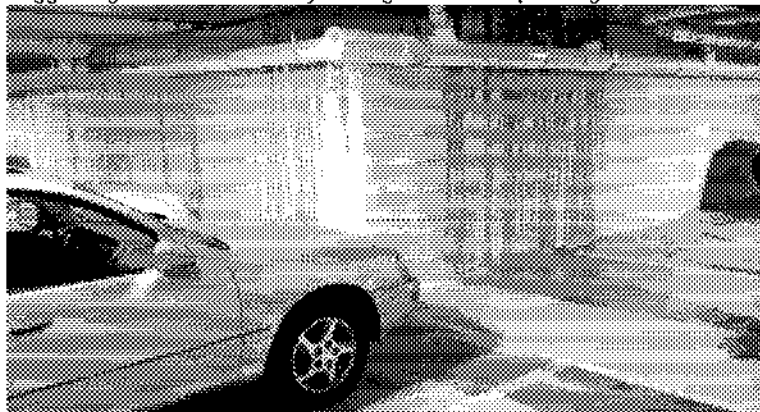
Garage, Level 2	#9	Significant amounts of water are seeping into the garage at the cold joint between podium deck & perimeter wall. Water intrusion appears to correspond exactly with location of demolished & rebuilt retaining wall above, and trench drain/sidewalk connection to podium deck above, suggesting that this work likely damaged the waterproofing.	
--------------------	----	---	--

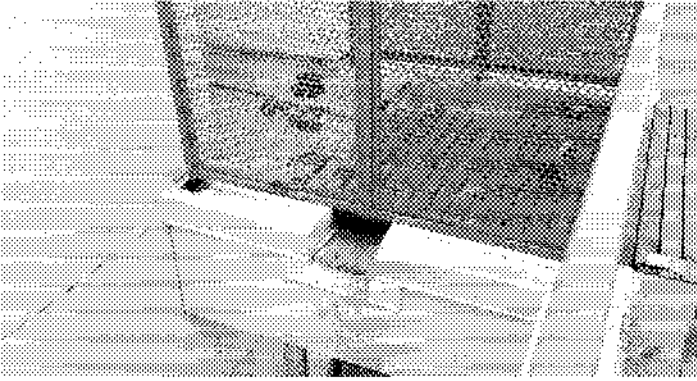
Location	Item	Description	Photo
Building 1, #11 Level 6, Drain outlet		Drainage outlet from 'bridge' to Office / North Deck was not constructed according to detail. It lacks the outflow extension needed to prevent water from cascading down the face of stucco below, and significant staining has already developed. Additionally, the parapet detail does not match the design: wood cladding covering the metal cap, running continuously over the drain outlet point.

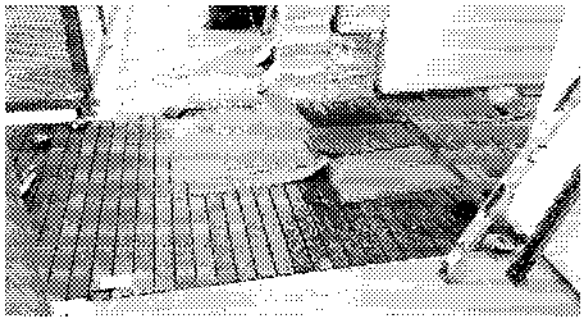
Building #12 1, Level 6		Wood pavers are unsealed & unprotected, debris accumulating.

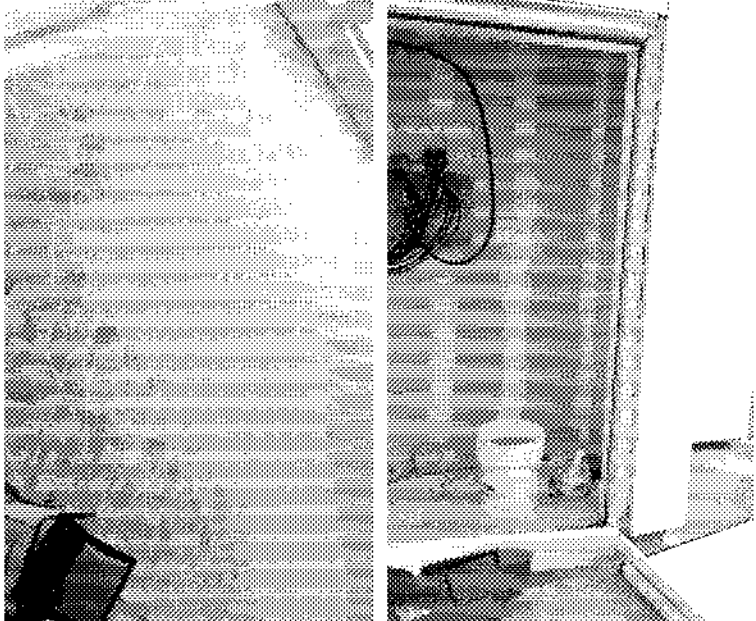
Building #13 1, Level 6		Fire extinguisher was discharged in the Leasing Office. South IDF closet door & frame appear to have been pulled out of the wall.

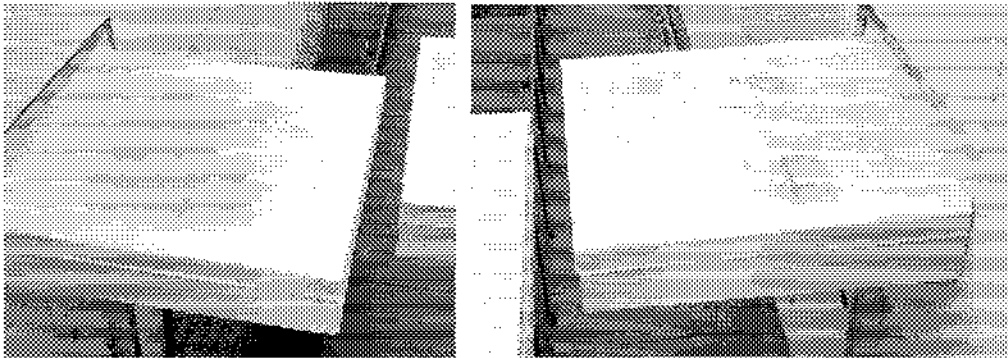
Location	Unit	Observation	Photo
Building 1, #14 Level 5		2 unit entry canopies on the south end have slight depressions in the center, causing water to pond on the TPO.

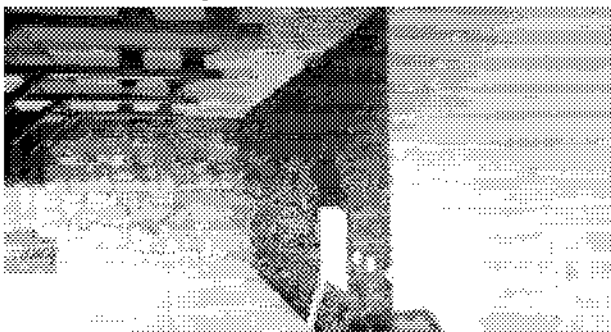
Location	ID	Report Notes	Photos
Level 2, Building 4 South	#1	Per RFI 118 response, the 'gap' between the north wall of the garage and the south wall of Building 4 is to be closed off by a 72" picket fence, for access control; not yet installed.

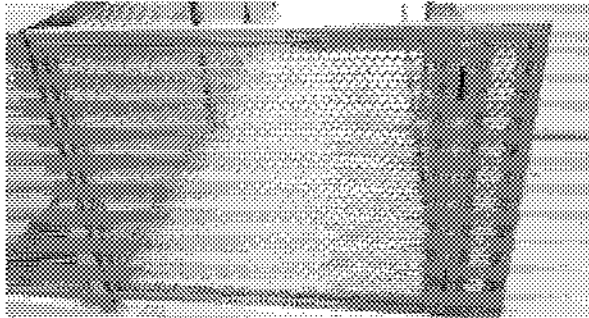
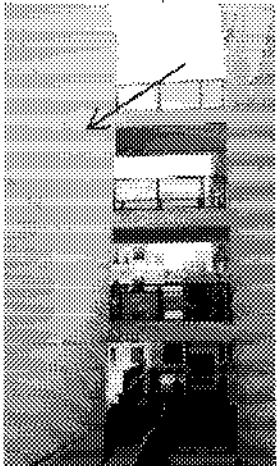
Level 3, Catwalk	#2	Catwalk is not yet complete. Gate hardware not installed at the west end. Expansion joint cover not installed at east end. Wall pack light missing from Building 3 north wall above catwalk.

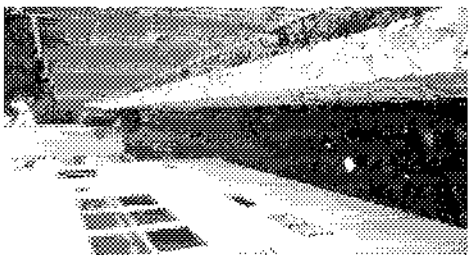
Wilson Street sideyard, Building 4	#3	Significant amount of standing water visible adjacent to Buildings 2 & 4, east side landscaped areas.

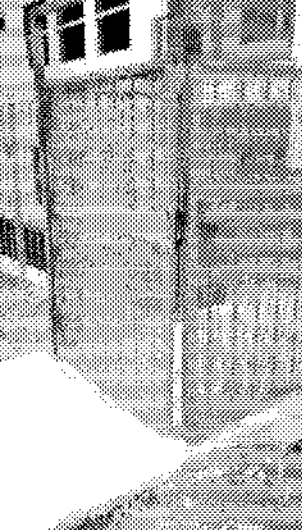
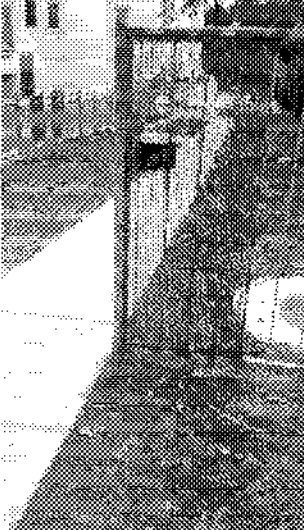
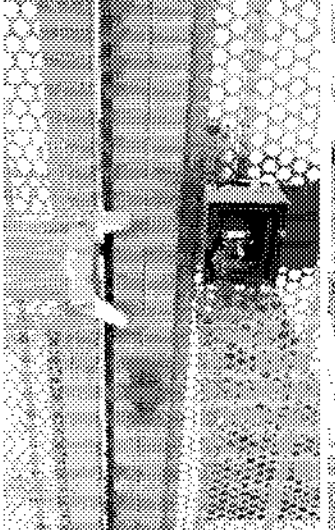
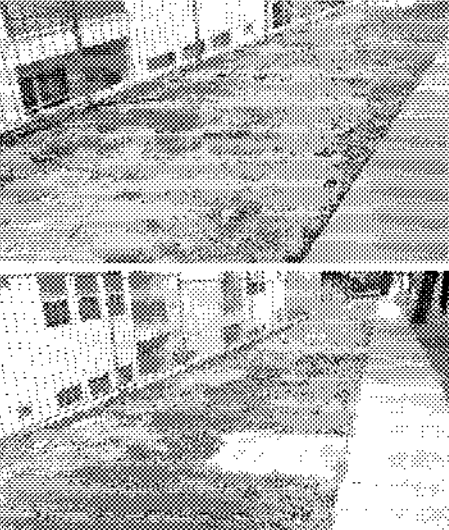
Wilson Street Fence	#4	New gate hinges installed. Hinges seem to possess good closing force, but gate does not consistently swing close on it's own, often stopping just short of latching. Knox boxes at north gate & mid-Building 4 gate have been opened. Landscaping along Wilson sidewalk not complete.

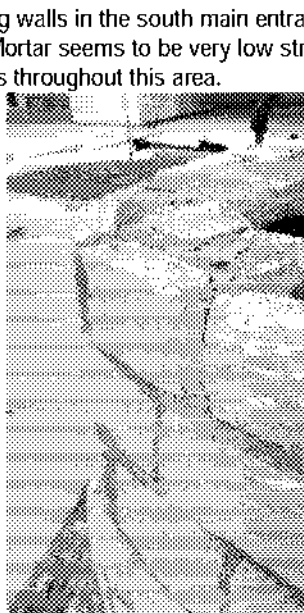
Retaining Walls	#5	Retaining walls in the south main entrance area (Pavilion) were observed to be extremely weak - able to be pulled apart by hand. Mortar seems to be very low strength with very weak bond to stones. This condition was observed in several locations throughout this area.

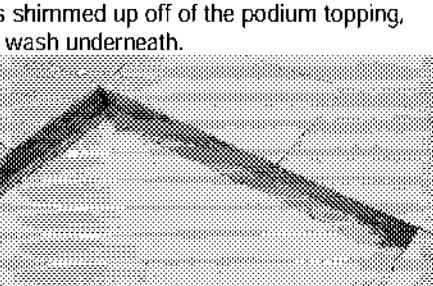
Building 1, Level 3	#6	Perforated gravel retainer strip is shimmed up off of the podium topping, which is likely to allow gravel to wash underneath.

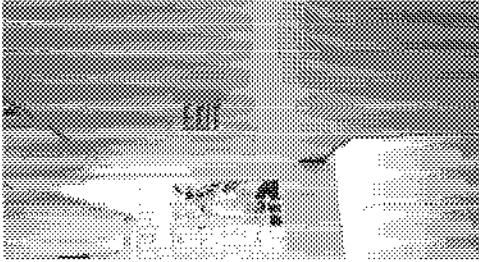
Building 3, Level 3	#12	Confirm that EXIT signage has correct arrow indicators and illuminated faces at all locations.

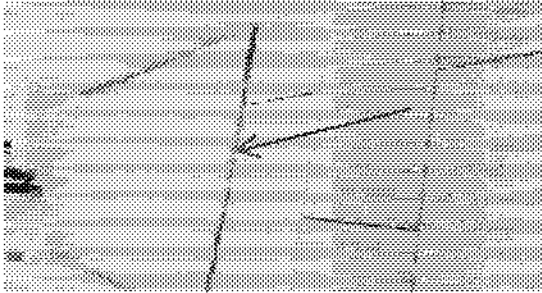
Building 3, Podium Deck	#13	Plywood form board still installed at paver/conc transition, near main breezeway entry

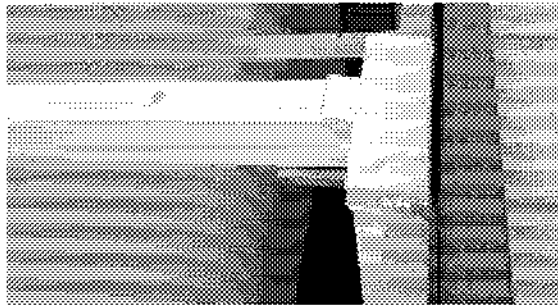
Building 1, #15
Level 6

Sheet metal pilaster caps have an odd 'flap' at the beam tie-in point, and sloppy visible sealant joints. Beams are to have sheet metal caps, per CD detail, not yet installed. Integrate pilaster & beam caps per specification quality standards for exposed sheet metal seams.

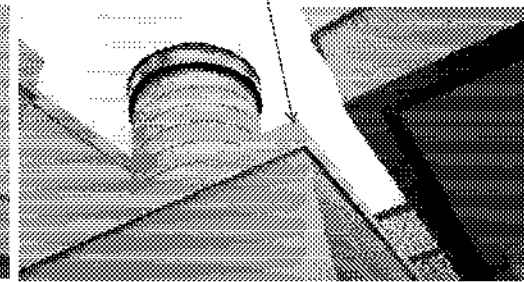
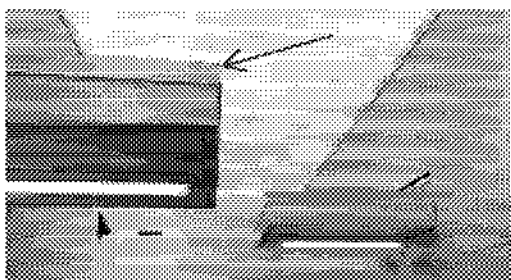
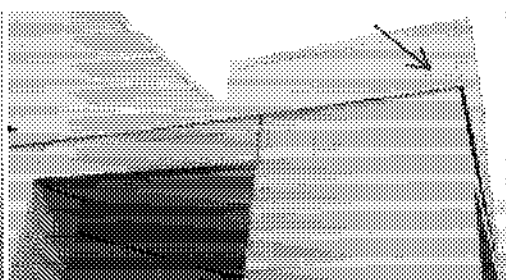
Buildings #16
1&3, Level
5&6

TPO seaming material has been used to seal sheet metal cap flashing at numerous locations. TPO material drops over the edge of the sheet metal cap flashing at other, seemingly random locations, visible from the walkway below. Multiple short pieces of sheet metal have been used to flash continuous edges at numerous locations, creating unnecessary joints. Gap visible under parapet cap flashing - flashing height not adequate to lap onto stucco below

Example of proper sheet metal corner - no visible sealant or TPO, tight straight seam

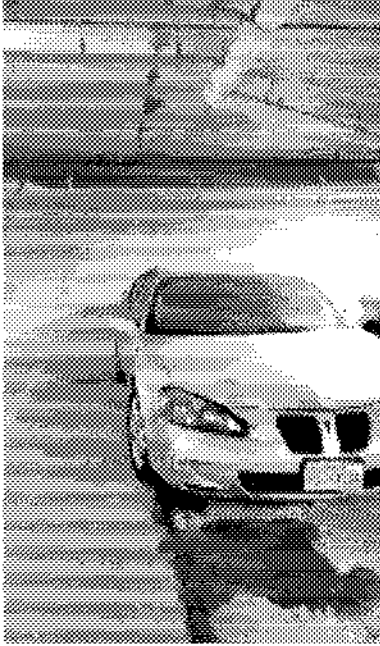
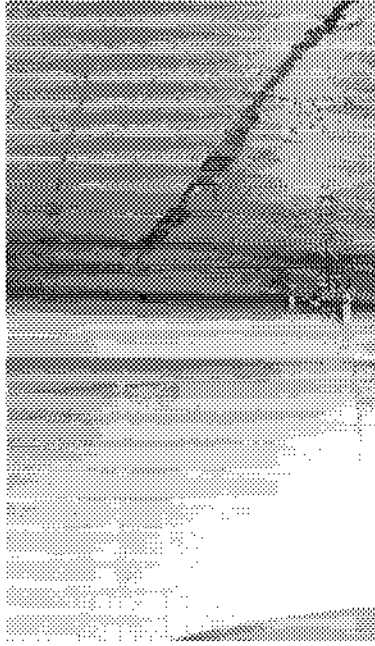
Location	Item	Description	Photo
Garage, G2, East wall	#17	Water is leaking down into the parking garage from the ceiling of the garage, over parking space #8.

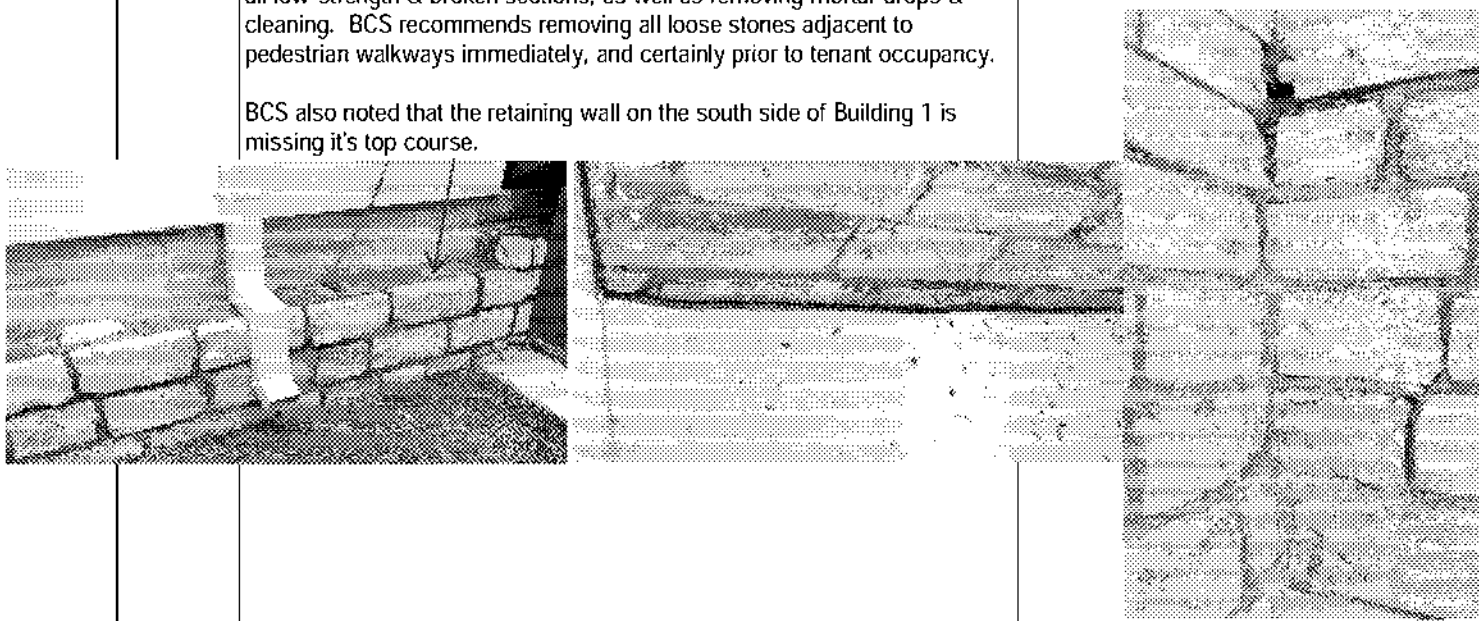
Garage Concrete	#2	Vertical concrete surfaces are partially finished, with un-finished walls remaining around the south end of the Garage.	
Retaining Walls	#3	<p>BCS, Weis, and ERWS met to review weak & crumbling retaining wall conditions. ERWS stated that their punch process will include re-building all low-strength & broken sections, as well as removing mortar drops & cleaning. BCS recommends removing all loose stones adjacent to pedestrian walkways immediately, and certainly prior to tenant occupancy.</p> <p>BCS also noted that the retaining wall on the south side of Building 1 is missing it's top course.</p>

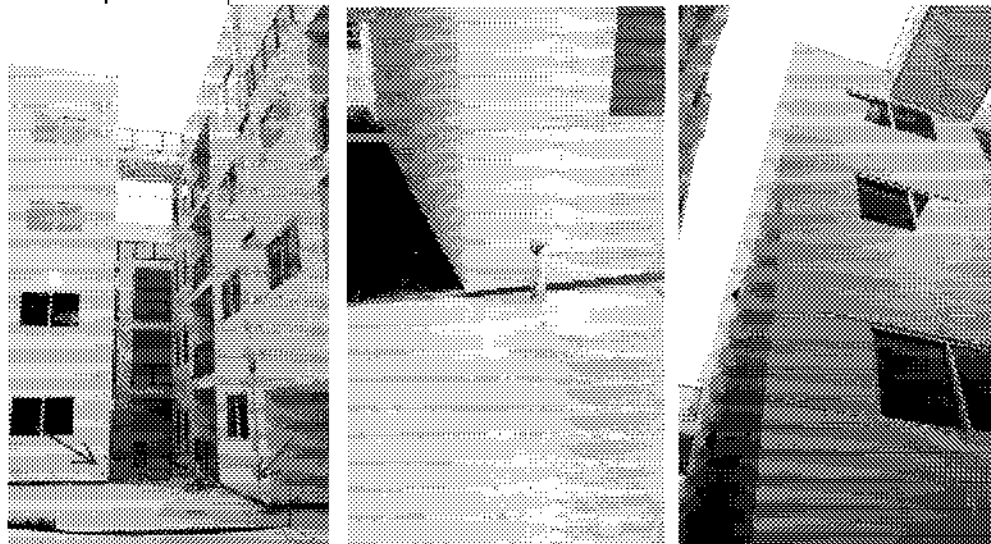
Buildings 1 & 3, Downspouts	#6	Two downspouts above the garage do not have a piped connection through the podium deck. If these discharge onto the topping slab, staining will result. Weis & BCS discussed - Weis will review with waterproofing subcontractor to determine if deck penetration is feasible. One downspout & overflow is missing. The garage penetration is in place.

Install missing downspout & overflow.
Door Paint, all

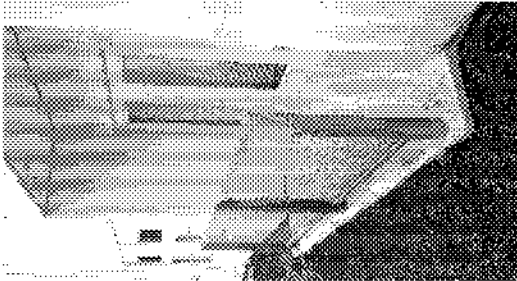
Location	Item	Observation	Photo
Building 3, Level 3	#7	Incomplete guardrails at unit balcony.

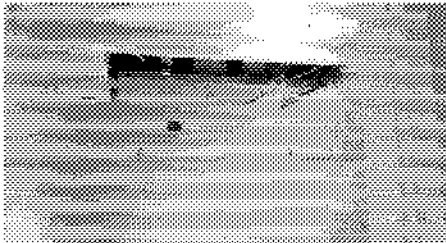
Fitness Room	#8	Interior finish out in progress. Confirm restroom ceiling is 7'-0" clear below AC unit. Exterior door to Community Room is locked but still able to be opened, due to missing strike plates.

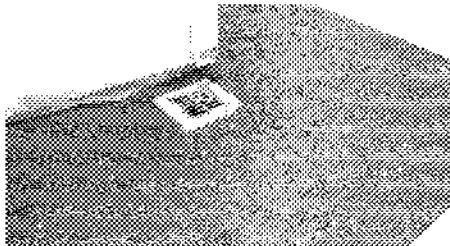
Level 3, Building 3	#9	Drain inlets at south side of Building 3 (2 total) are to be buried below gravel covering, per PCO-049. Provide filter screens to prevent wash out. Recommend waiting for gravel exchange to make this adjustment.

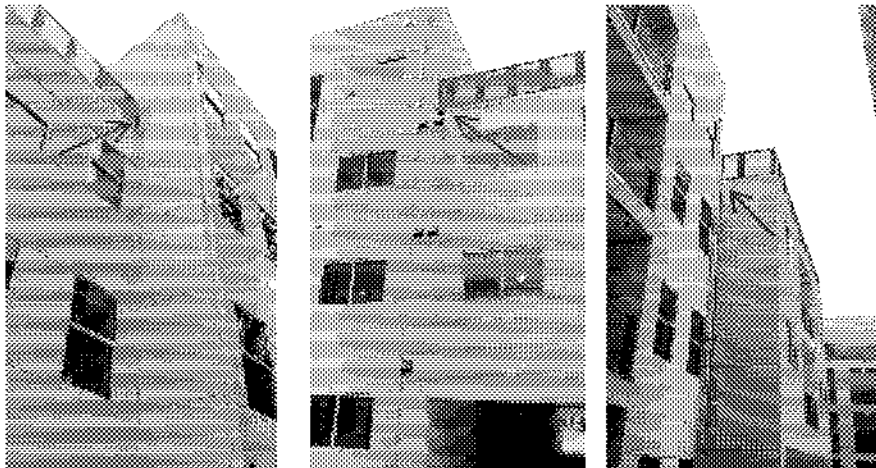
Building 3, Roof deck drains	#10	The outlets from the North & South Roof Decks are not tied into the adjacent downspouts as designed. They currently discharge down the face of the building and have caused staining.

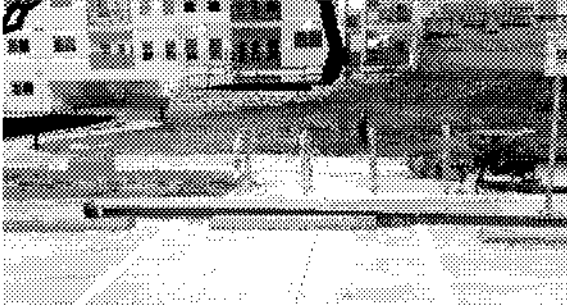
Location	Item	Description	Photo
Surface Parking, SE	#11	Pole light on site, awaiting installation.

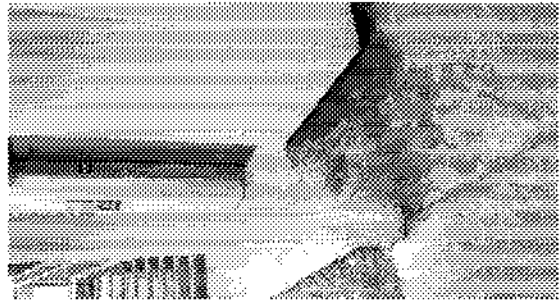
Building 4, Elevator, Level 2	#13	Concrete foundation depression traps & holds water against the elevator shaft; should slope to drain away.

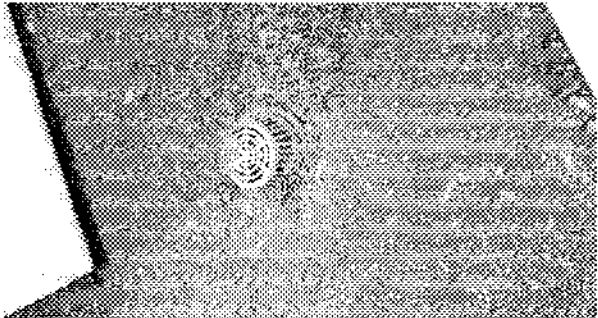
Building 4, Level 2	#14	Landscaping area drain missing screen cover.

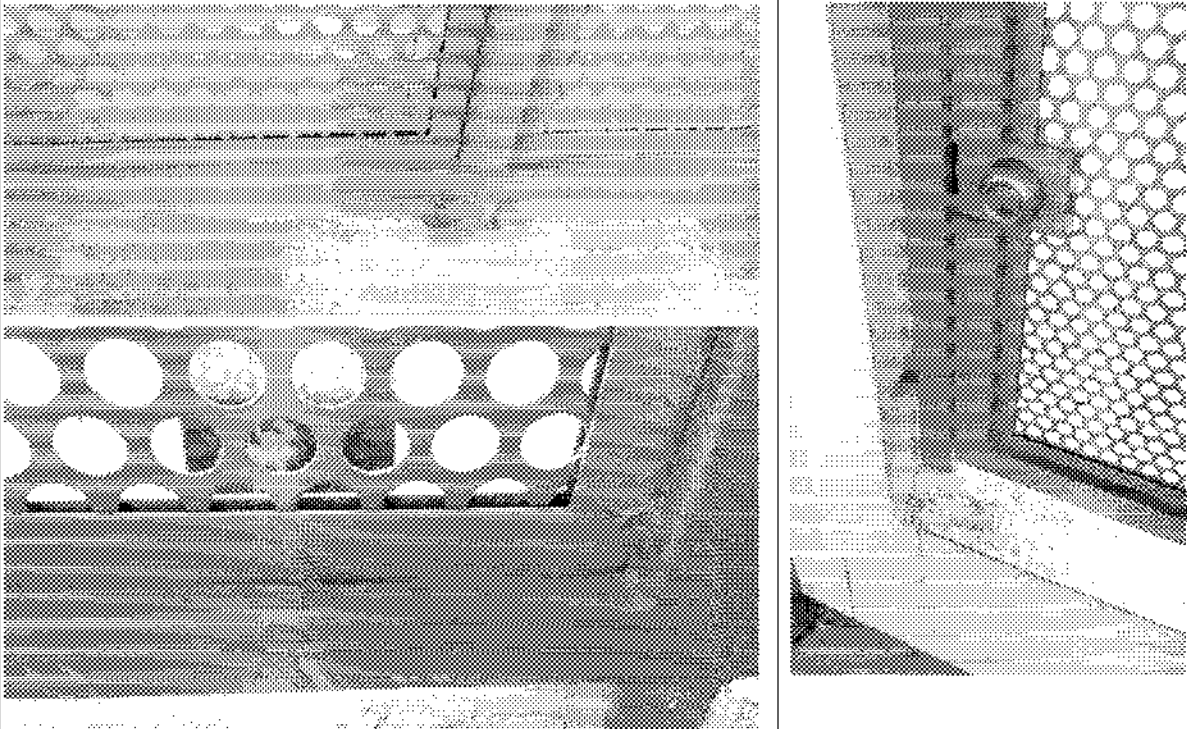
Lighting	#2	<ol style="list-style-type: none"> 1. Light shields on the north end of Building 1 still need to be re-done. 2. Several breezeway lights aren't installed yet in the main entrance. 	
Railings	#3	<p>Rust was observed at many locations on the guardrails. The interior side of the perforated panel frames appear to be unpainted.</p>

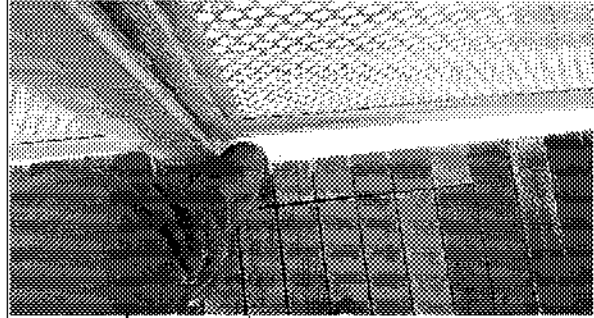
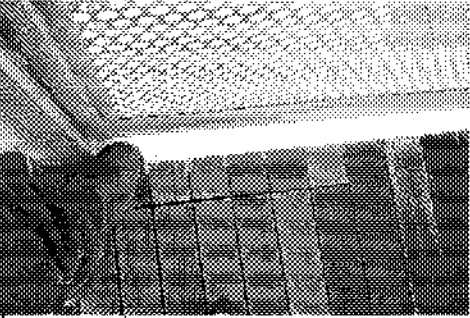
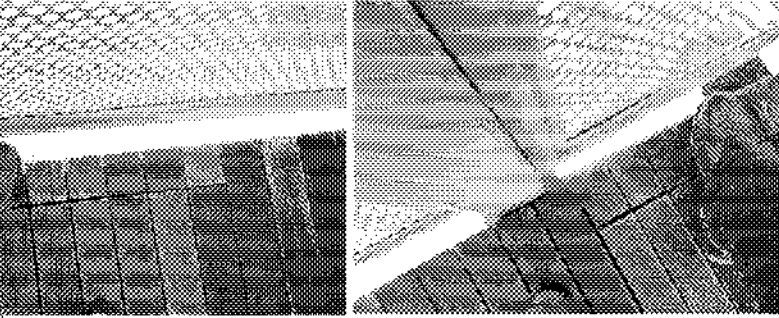
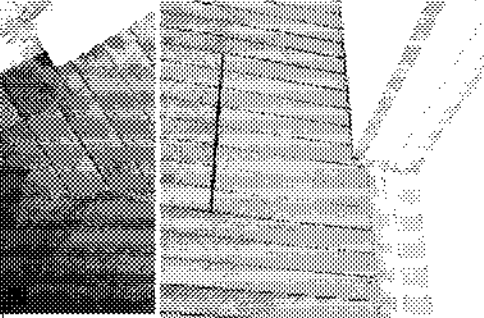
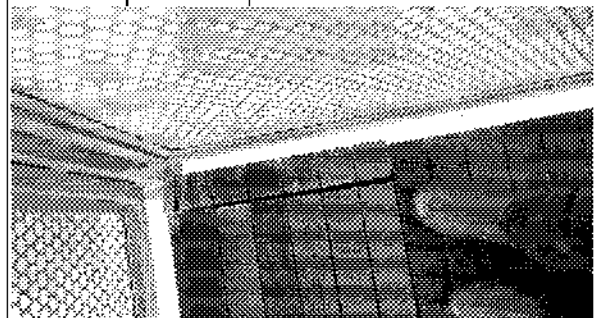
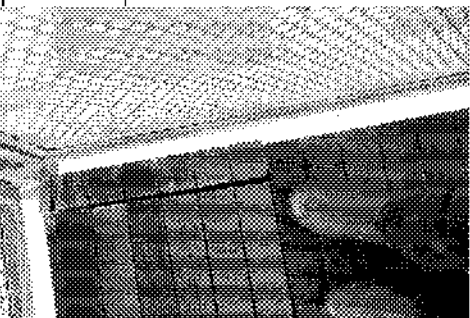
Level 6 Deck	#4	Many wood deck tiles are loose or improperly supported, especially cut tiles around the perimeter.

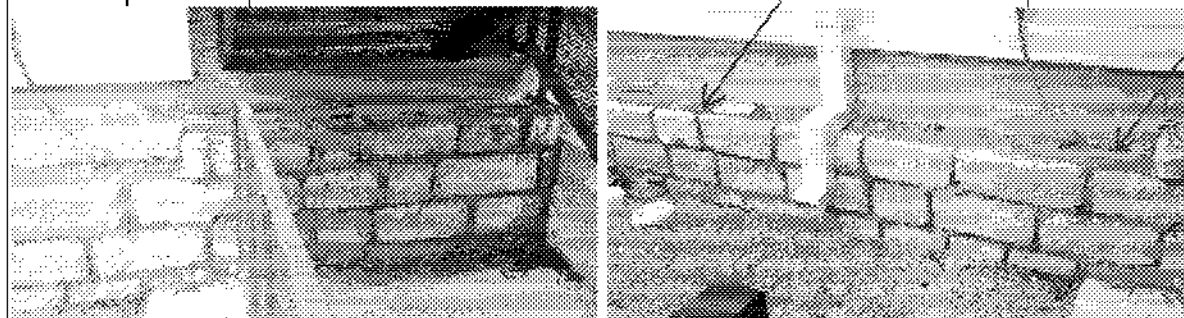
Location	ID	Notes	Images
Retaining Walls	#1	Additional retaining wall correction items: 1. Drain piping should not protrude beyond the face of the wall. Piping is very thin-walled and fragile, and will be subject to breakage - cut off excess pipe flush w/ surrounding mortar. 2. Wall adjacent to Building 1 south face is unfinished, missing part of the top course. Top edge is poorly capped.

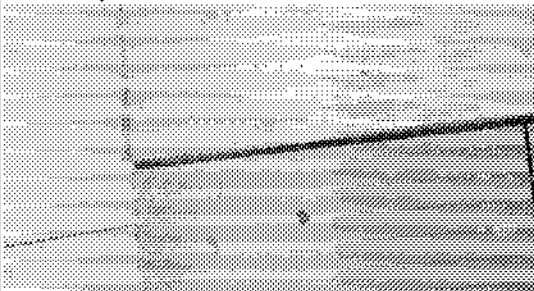
Ramp Transitions	#4	<p>Old OSB forms have been removed from ramp transitions to pavers. The resulting 5/8" to 7/8" gap will need to be filled in flush with a durable, traffic-rated material (redwood, cedar, concrete) to provide a TAS-compliant route.</p>

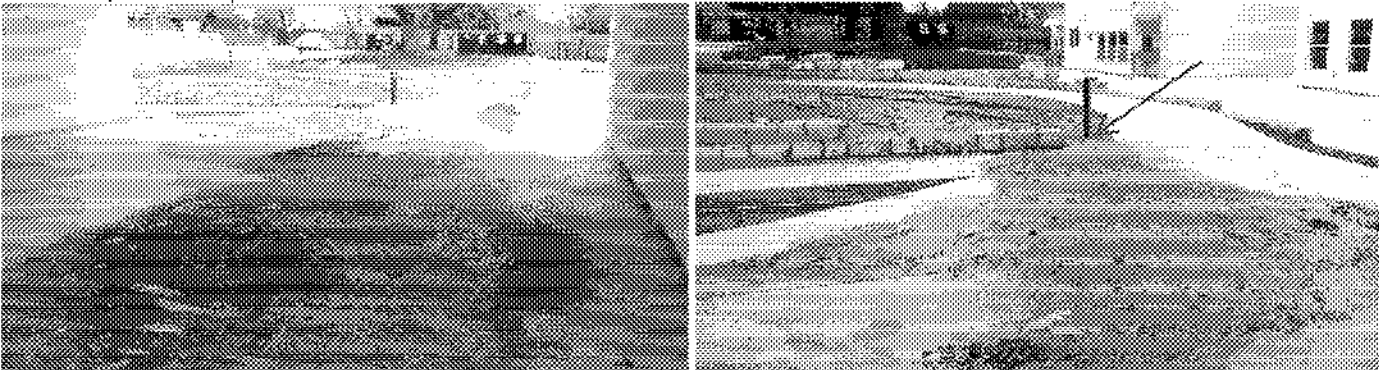
Podium Entrance	#5	<p>Large amounts of soil run-off observed on the podium deck after this weekend's rain. Trench drain and several area drains will likely need to be cleaned out. Recommend either extension of the retaining wall, or installation of silt fence until this area is landscaped.</p>

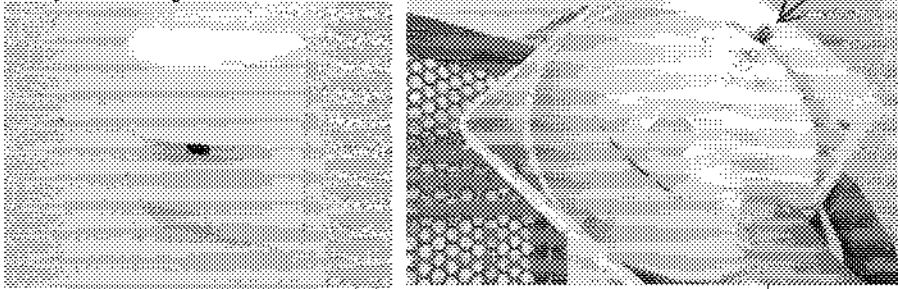
Wall-mount t path lights	#7	<p>Along top floor walkways, several of the low-level path lights have the covers removed / knocked-off. One of the displaced covers didn't have it's set-screw tightened, causing it to fall off easily. Check that these are adjusted for tight fit.</p>

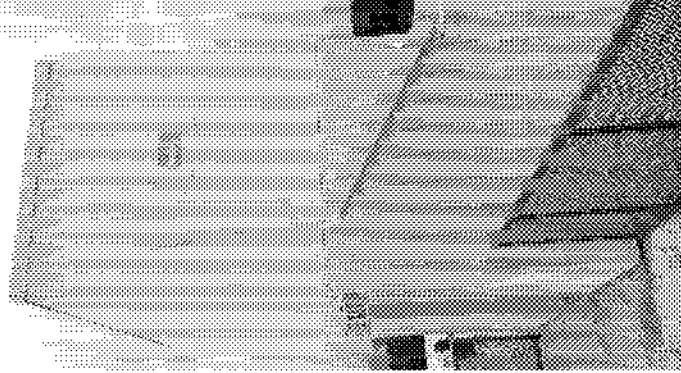
Building 4 Downspout	#8	<p>The downspout on the south face of Building 4 was installed incorrectly. The RFI-121 response called for this downspout to be located on the east face of the trash vestibule roof, running down to the Level 4 roof just below it.</p>

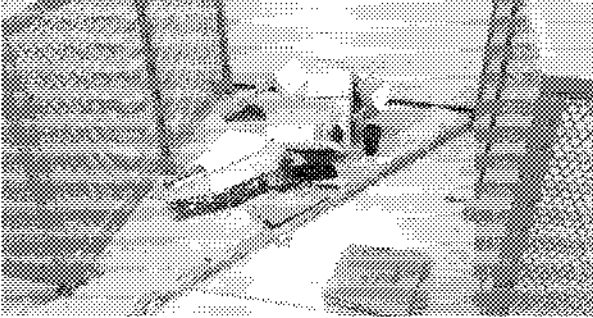
Building 3, Level 6	#9	<p>Construction debris outside the door of an occupied unit.</p>
